# CÂMARA MUNICIPAL DE ARARAQUARA

## INDICAÇÃO Nº 318/2024

Manutenção corretiva em hidrante localizado na Rua São Vicente de Paulo, confluência com a Av. Santa Cecília, no bairro Vila Xavier.

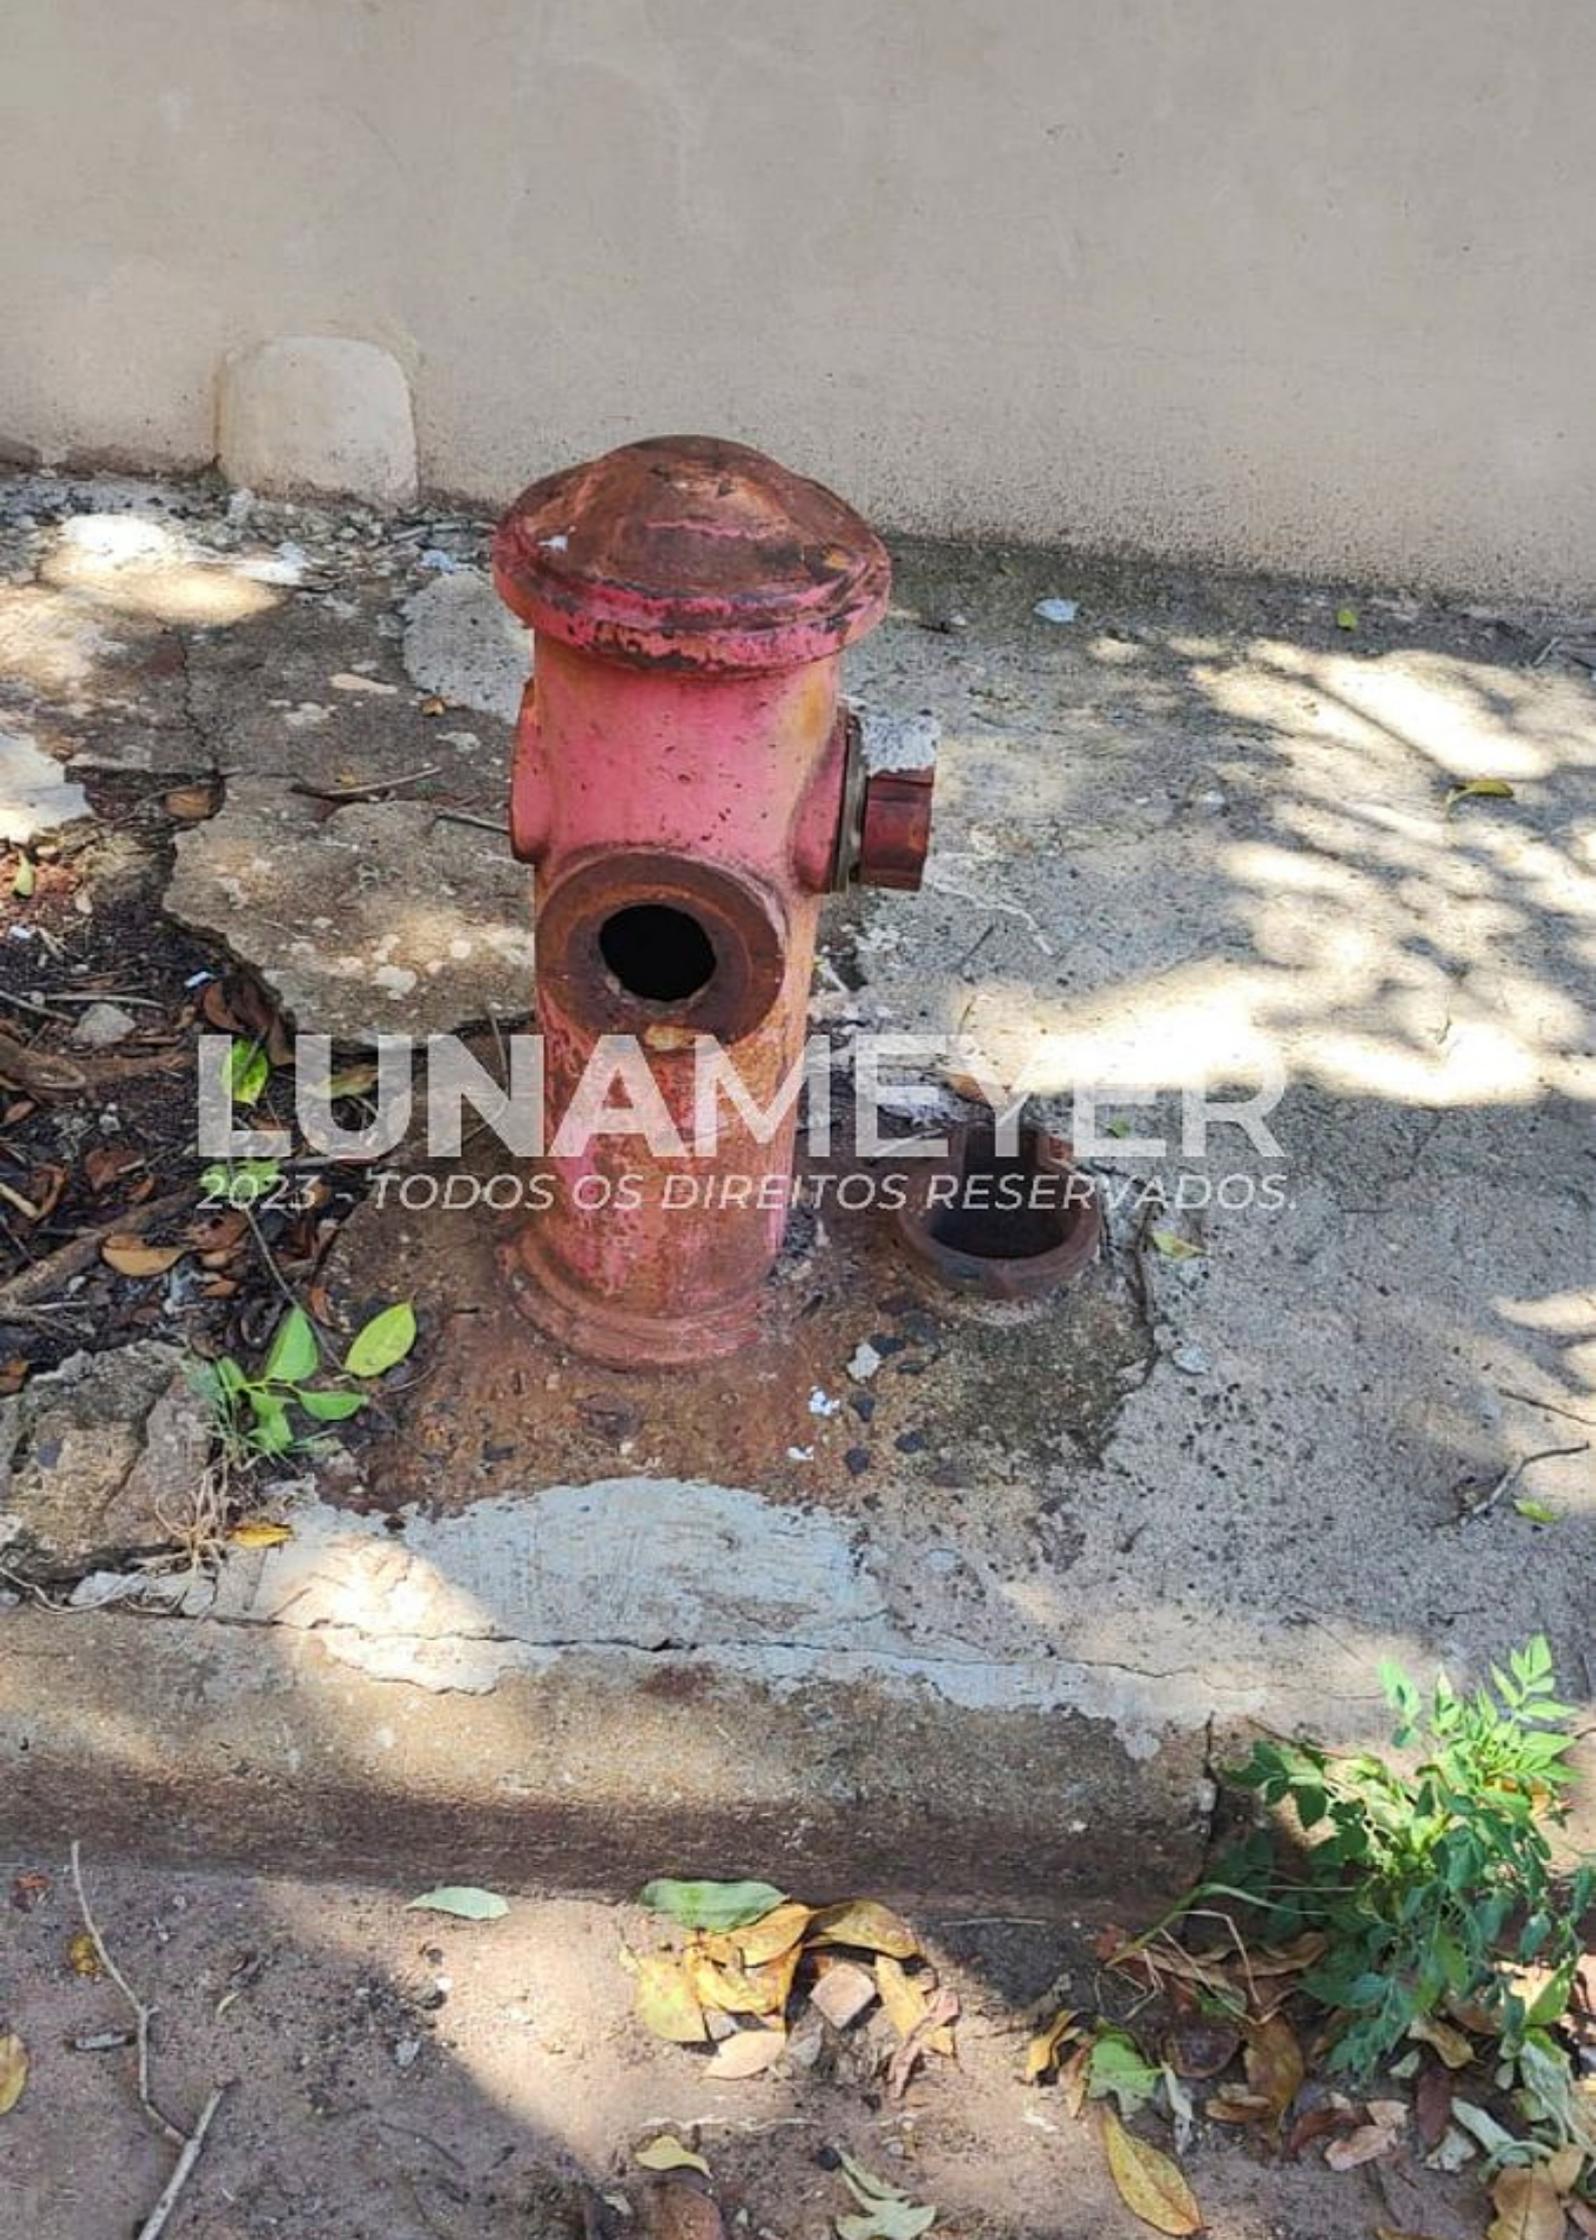
Conforme verificado por este gabinete, o hidrante está inoperante por falta de manutenção. Há peças ausentes no equipamento. Visto que a região possui muita mata nativa e terrenos baldios sem manutenção, é necessário seu reparo para que em caso de necessidade, possa ser acessado para uso. Agradeço a atenção dispensada e fico ao aguardo das devidas providências.

Indico ao senhor Prefeito Municipal a necessidade de entrar em entendimento com os setores competentes, no sentido de que se seja feito contato com o Corpo de Bombeiros para que seja realizada a manutenção corretiva em hidrante localizado na Rua São Vicente de Paulo, confluência com a Av. Santa Cecília, no bairro Vila Xavier.
